FINAL REPORT
MAY 1993

REPORT NO. 93-20

TRANSPORTATION TEST OF
M876A1 U.S. MARINE CORPS
(USMC) TELEPHONE
MAINTENANCE TRUCK (TMT)

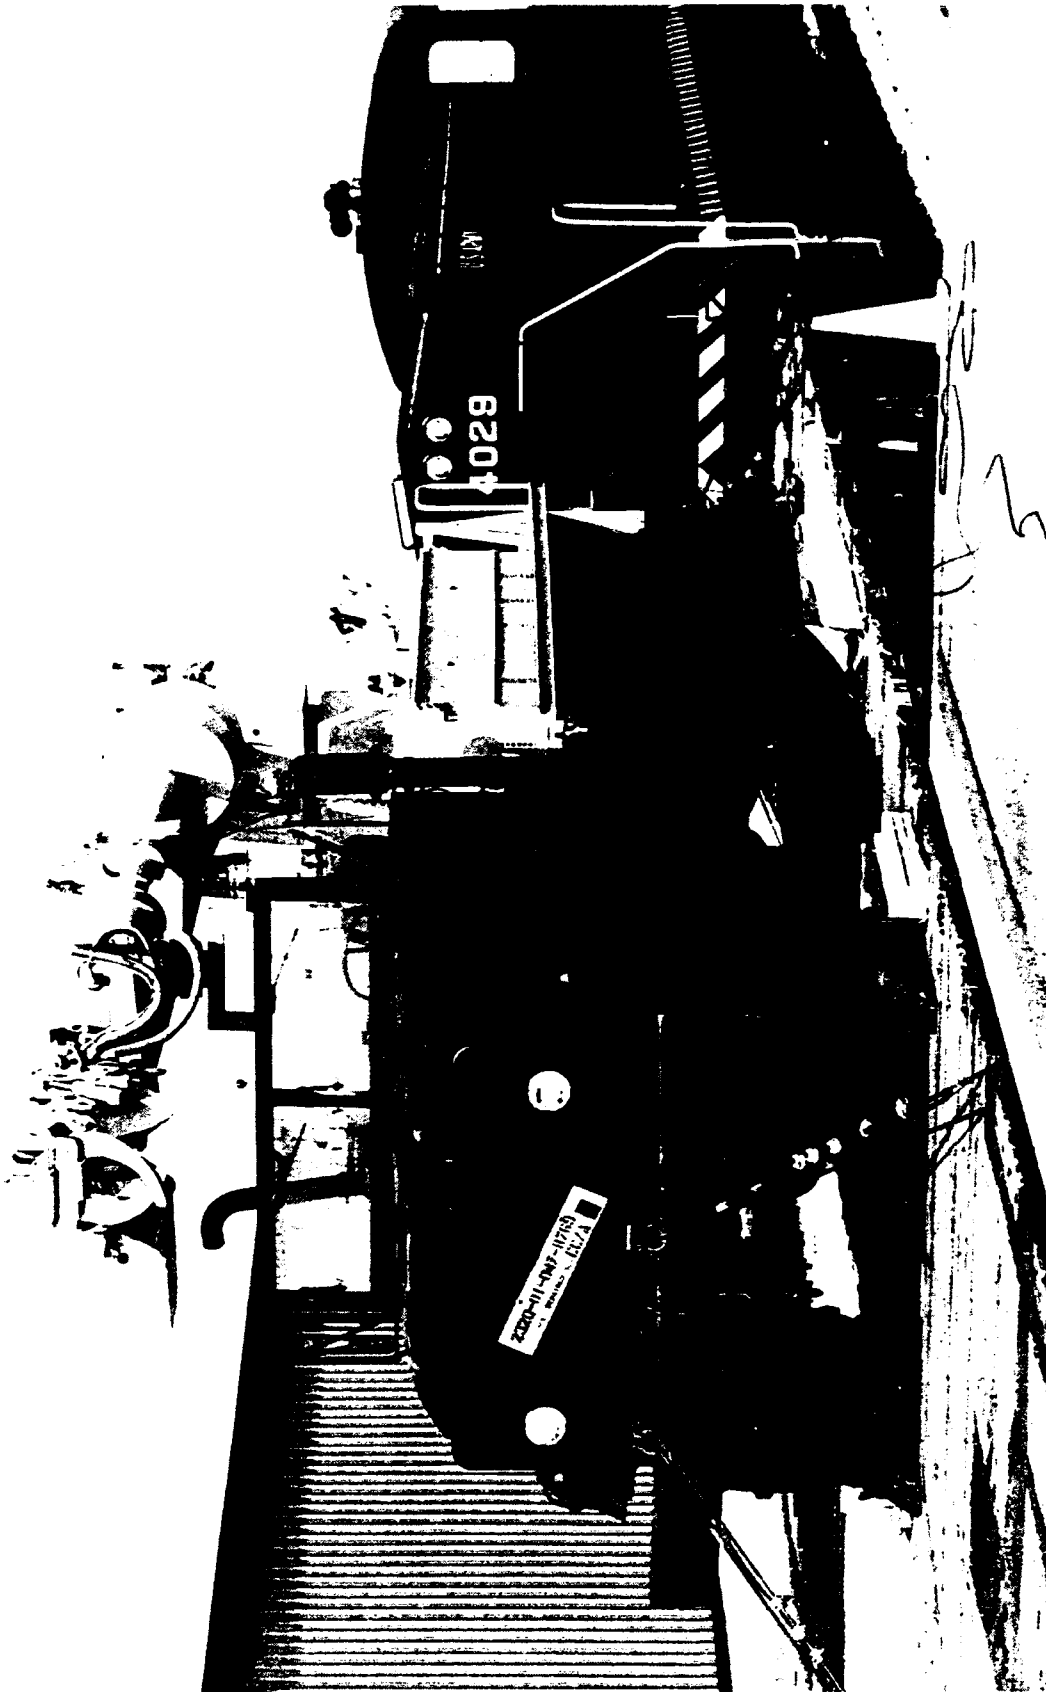
PHOTO NO. A0317 SCN93-152-1868. This photo shows U.S. Marine Corp M876A1 TMT with a commercially-fabricated truck bed. The truck is undergoing rail impact testing to verify its multimode-transportability capability.

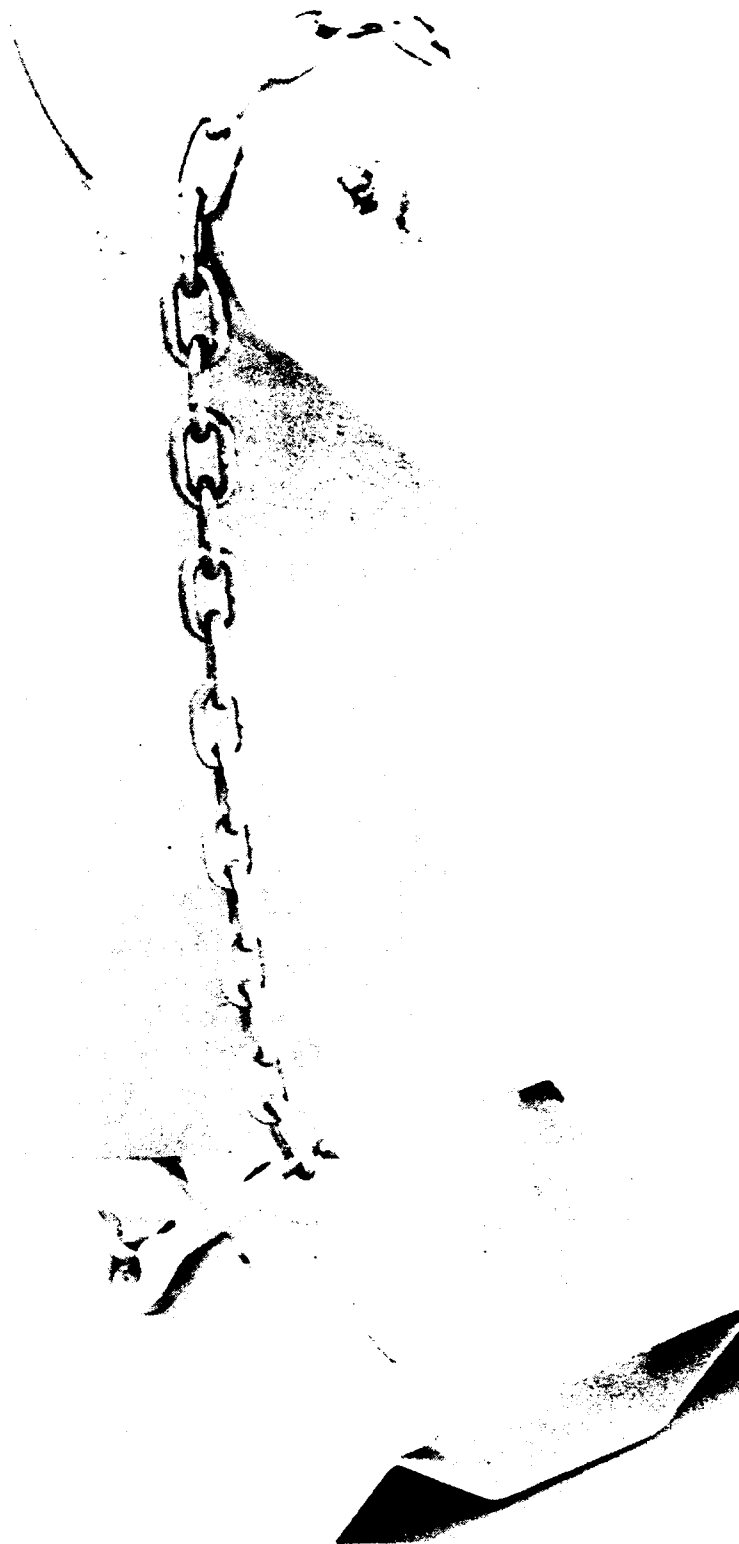
PHOTO NO. A0317 SCN93-152-1876. This photo shows a closeup of the 30-inch auger mounting brackets showing the welding to the equipment cabinet tops. This mounting configuration is insufficient to secure the auger during rail transportation. The chain is looped over the auger shaft and welded to the mount.
